**Update to the Kittiwake Letter of Application from the Cayman Islands
Department of Transportation, MARAD, dated November 5th, 2006
Update December 21st, 2007**

This document is an update to the Kittiwake Reefing Plan and application to MARAD for the donation/transfer of a ship for artificial reefing purposes to the Cayman Islands.

**Kittiwake Paint Test Results: Original Batch of 121 Samples
May 17, 2006
Universal Laboratories, Hampton, VA**

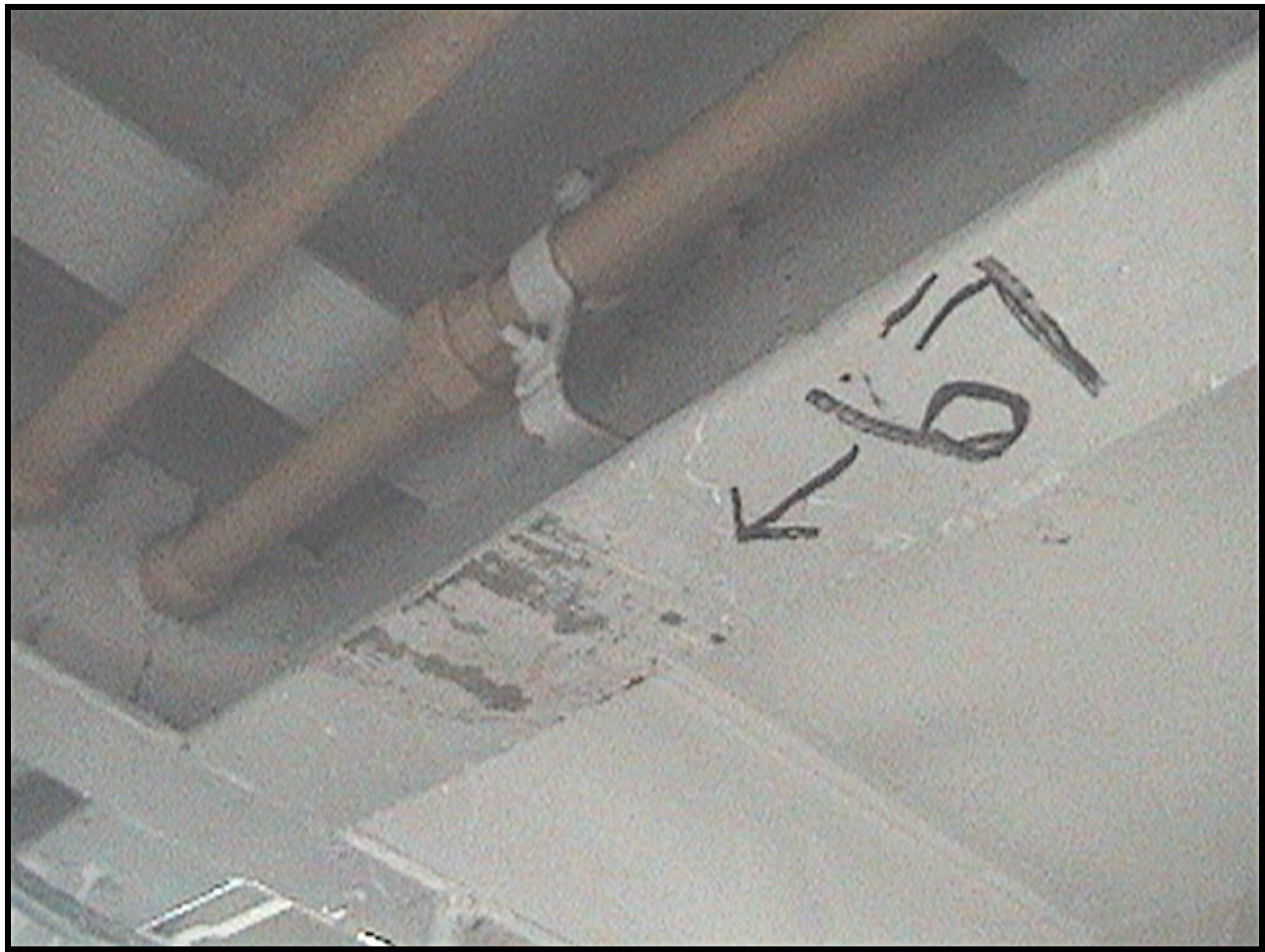
One sample indicated a concentration level of 108ppm of Arcolor 1262. This is referred to Sample #67. The sample was taken on the overhead, main propulsion, lower starboard side B-204-E Frame 79. The sample was white paint. Of the 121 samples taken, there were a total of 35 samples that were white paint, with none of the other white paint samples showed any Arcolor 1262. Other white paint samples were taken from the fan room, interior bulkheads, shaft alley, diving bulkhead, recompression chamber and overhead, bulkhead in welding, forward bulkhead including distribution compressor, lower main engine room, air compressor room, lower storeroom, electronics storeroom, bosuns lockers, overhead above the generator sets, overhead main propulsion, sonar room and main propulsion room. All white paint, including sample #67 is common, standard Navy white paint (150 or 151).

Kittiwake Paint Sample #67 – PCB Contamination area on the overhead

Our remediation plan is to remove all metal and paint (everything) from the affected area, instead of just removing the paint. The effected area is in the engine room, on the underside of the deck, between the upper and lower engine room. The area is on the starboard side within the watertight space, but does not make up any part of the watertight shell, and removing the steel from this area would simply be a diver penetration or access and not affect the ship's water-tight integrity for towage or sinking. We have sampled the affected paint area until a clean or non-contaminated area in a 360 degree circumference of the contaminated area is found. We will remove all paint in this area making a clean margin, and then using a plasma cutter, we will cut out the metals and steel and dispose of the paint and steel as PCB contaminated materials.
